NDE OF BLACK HAWK HELICOPTER ROTARY WING-HEAD SPINDLE
THREADS USING ELECTRIC CURRENT PERTURBATION

Final Report
SwRI Project 15-7958-818

U. S. Army Aviation Research and
Development Command
St. Louis, Missouri

November 1985

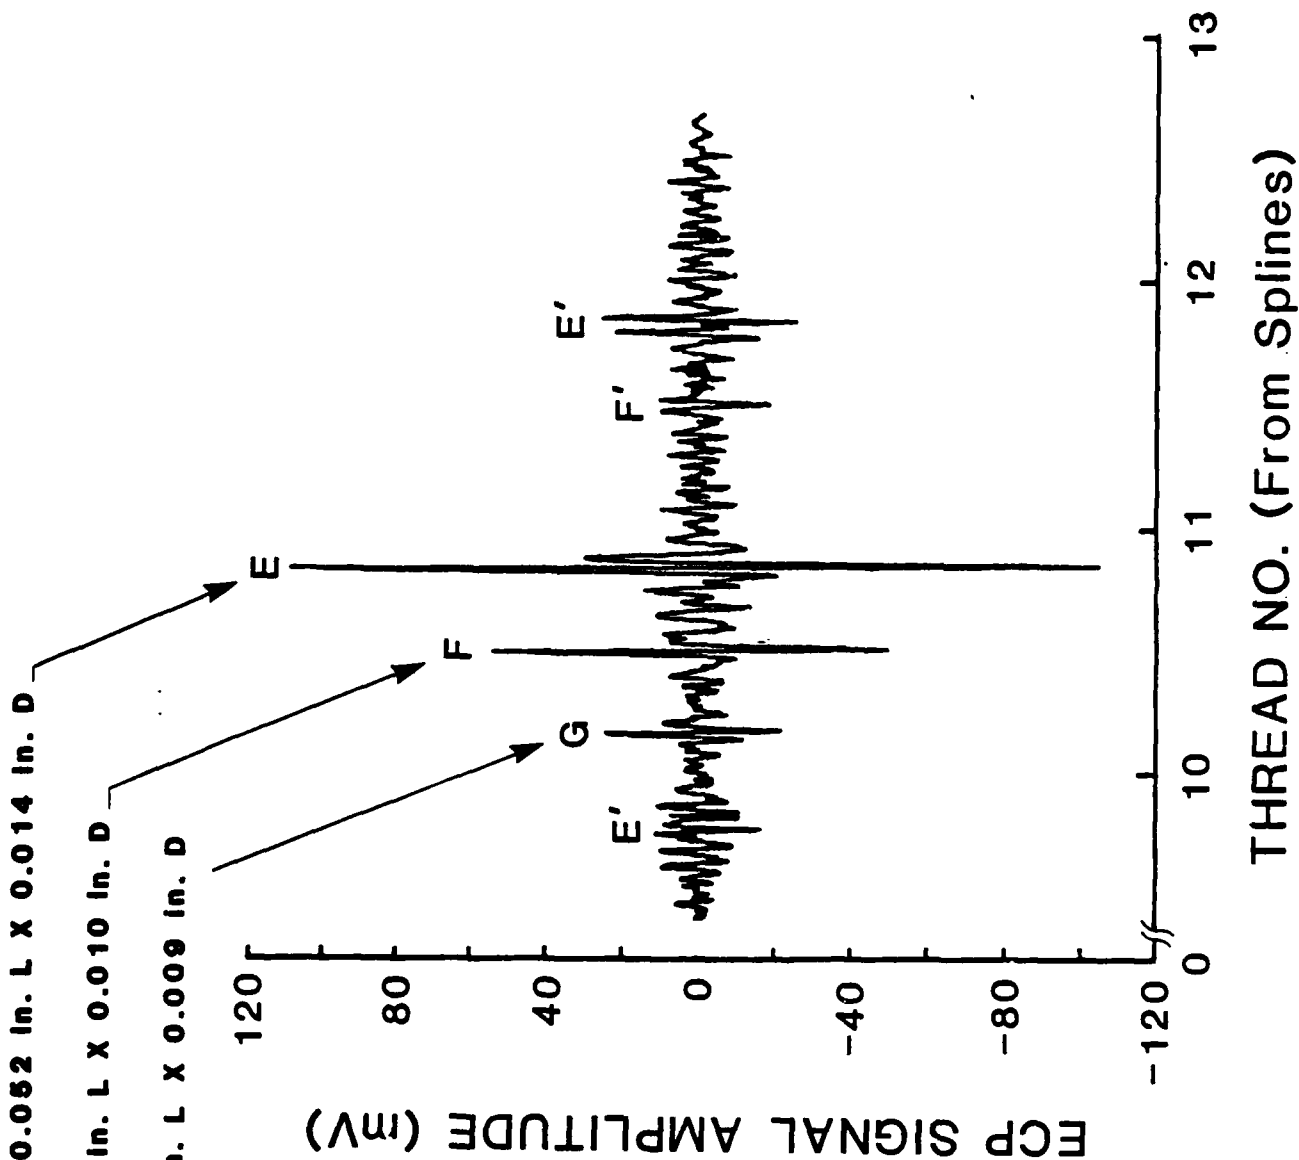
ECP data were initially obtained from "standard" specimen No. 1 (used in the previous project) to establish the laboratory setup. This spindle was of the older design (-102). Only the threads in the area of the flaws were scanned. ECP signals from artificial flaws E, F, and G in specimen No. 1 are shown in Figure 2. Distinct signals are obtained from all three flaws including the smallest (flaw G) which is 0.021 in. long x 0.009 in. deep. Note that satellite signals (E' and F') are obtained from the larger flaws (E and F) when the probe is located over adjacent threads. Flaw F (0.039 in. L. x 0.010 in. D.) gives a signal-to-background ratio greater than 2:1 when compared to the background signals from spindles 1 through 6.

FIGURE 2. ECP SIGNALS FROM FLAWS E, F, AND G IN SPECIMEN NO. 1. SIGNALS OBTAINED WHEN THE PROBE IS LOCATED OVER THE ADJACENT THREAD ARE DESIGNATED E', AND F'. FLAW DIMENSIONS ARE LENGTH X DEPTH.

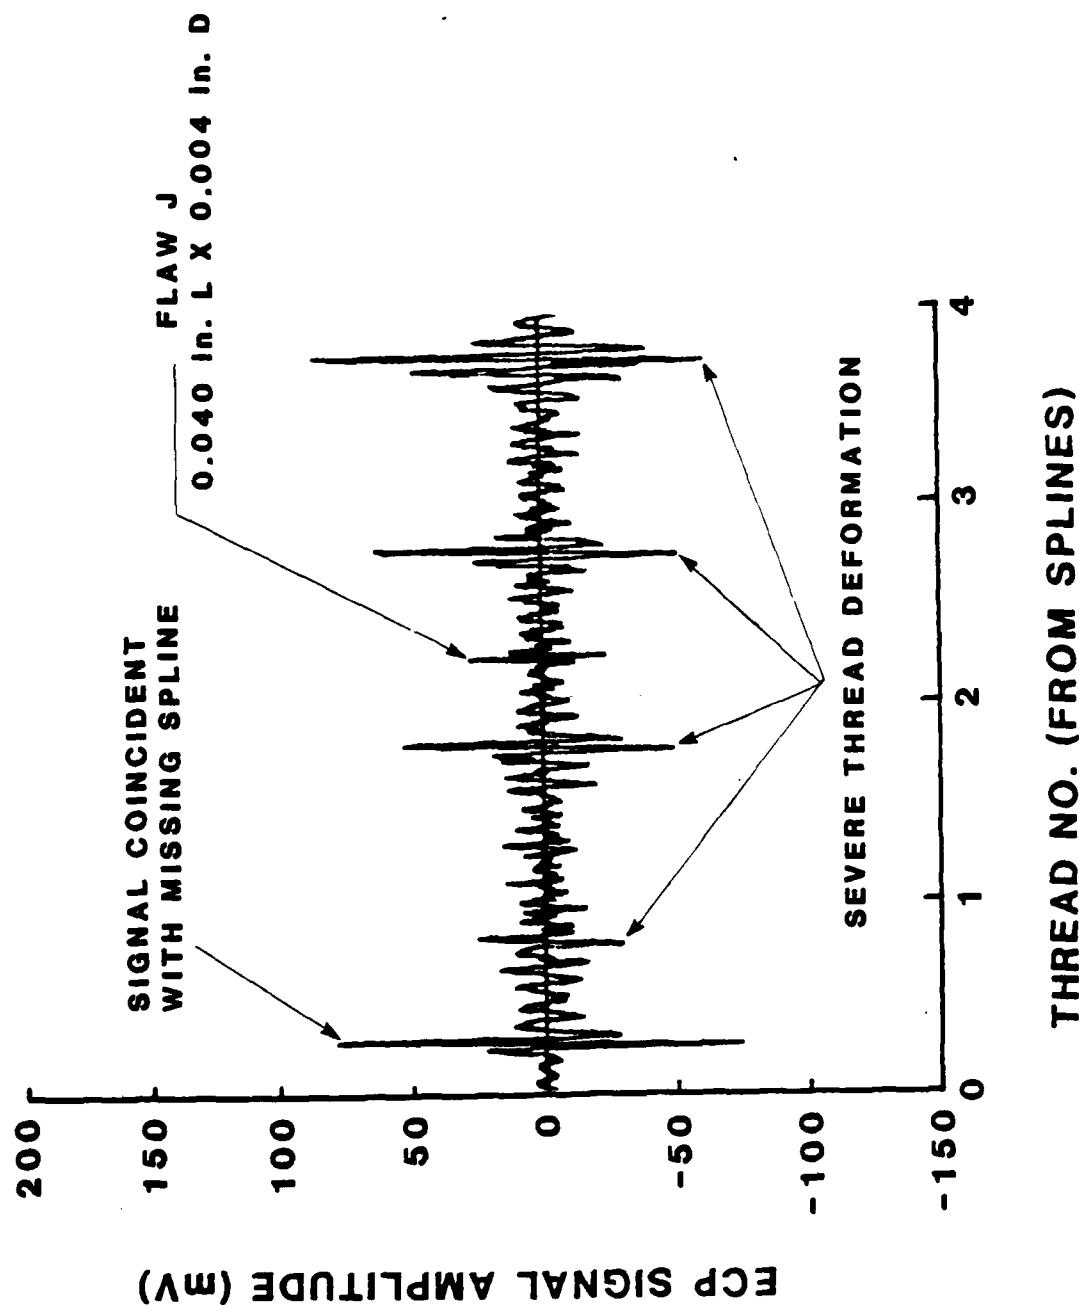
A flaw-like ECP indication was obtained in the first thread at a position corresponding to the missing spline (Figure 3). The source of this indication is not clear; however, it is unlikely that it is caused by a flaw since an indication was obtained at the same location on each of the spindles inspected. It is possible that the ECP probe is actually sensing the missing spline.

A signal from flaw J (0.040 in. L. x 0.004 in. D.) is also shown in Figure 3. Note that the signal amplitude from this flaw is slightly greater than the background signal level in regions where no flaws and no thread deformation are present. ECP signals from flaw K (0.040 in. L. x 0.015 in. D.) are shown in Figure 4. Note that a satellite signal, K', is obtained when the probe is positioned over an adjacent thread.

FIGURE 3. ECP SIGNALS FROM SPECIMEN NO. 2, THREADS 0-4

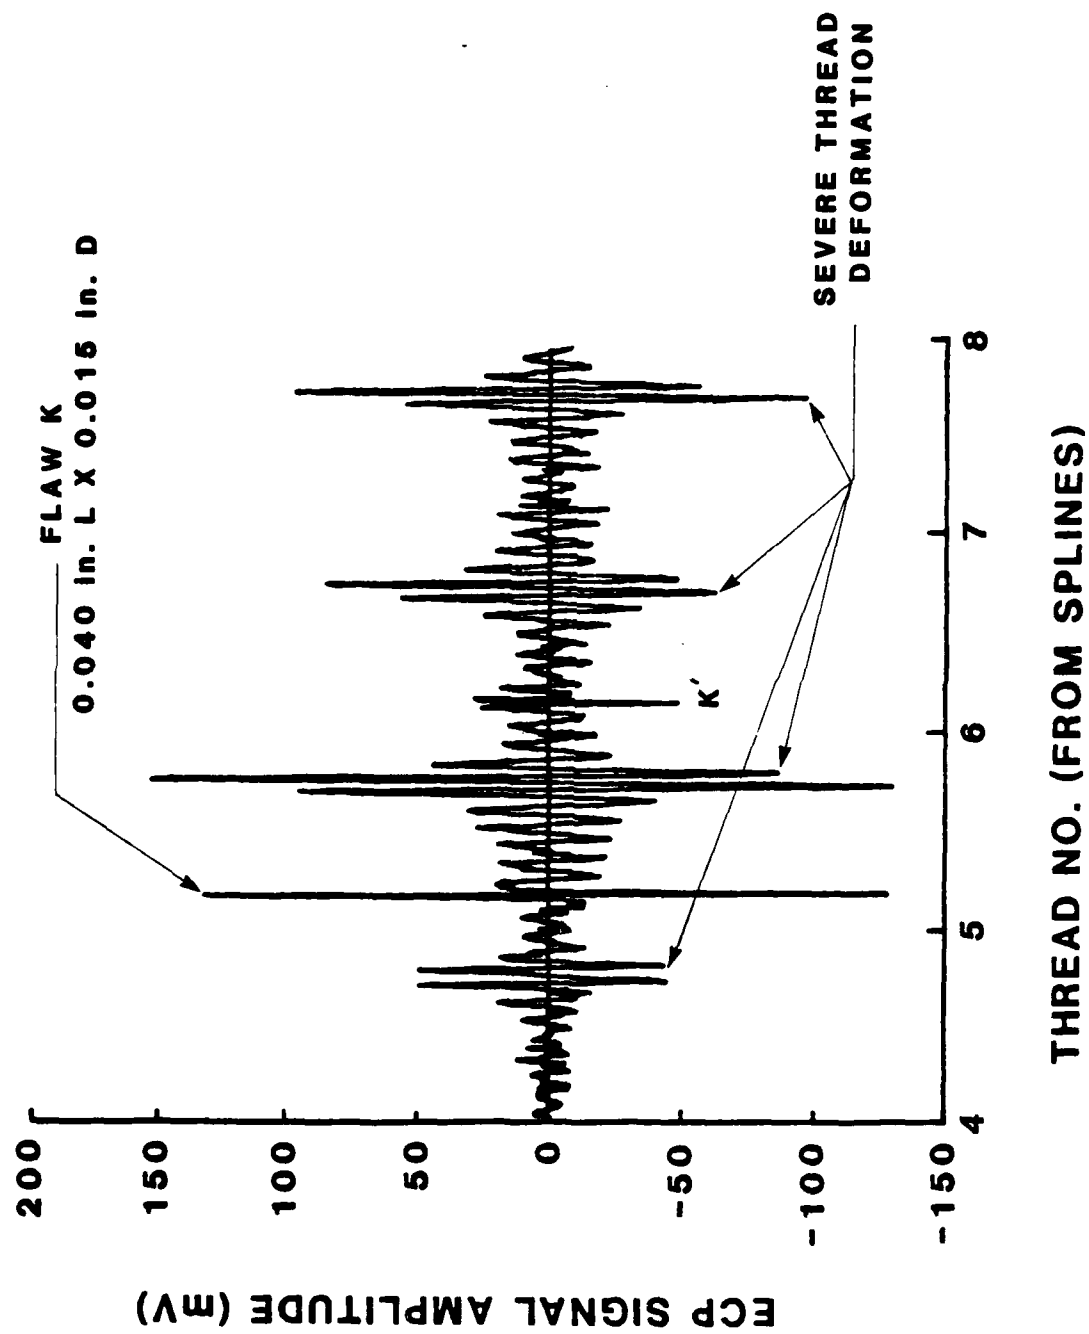
FIGURE 4. ECP SIGNALS FROM SPECIMEN NO. 2, THREADS 4-8

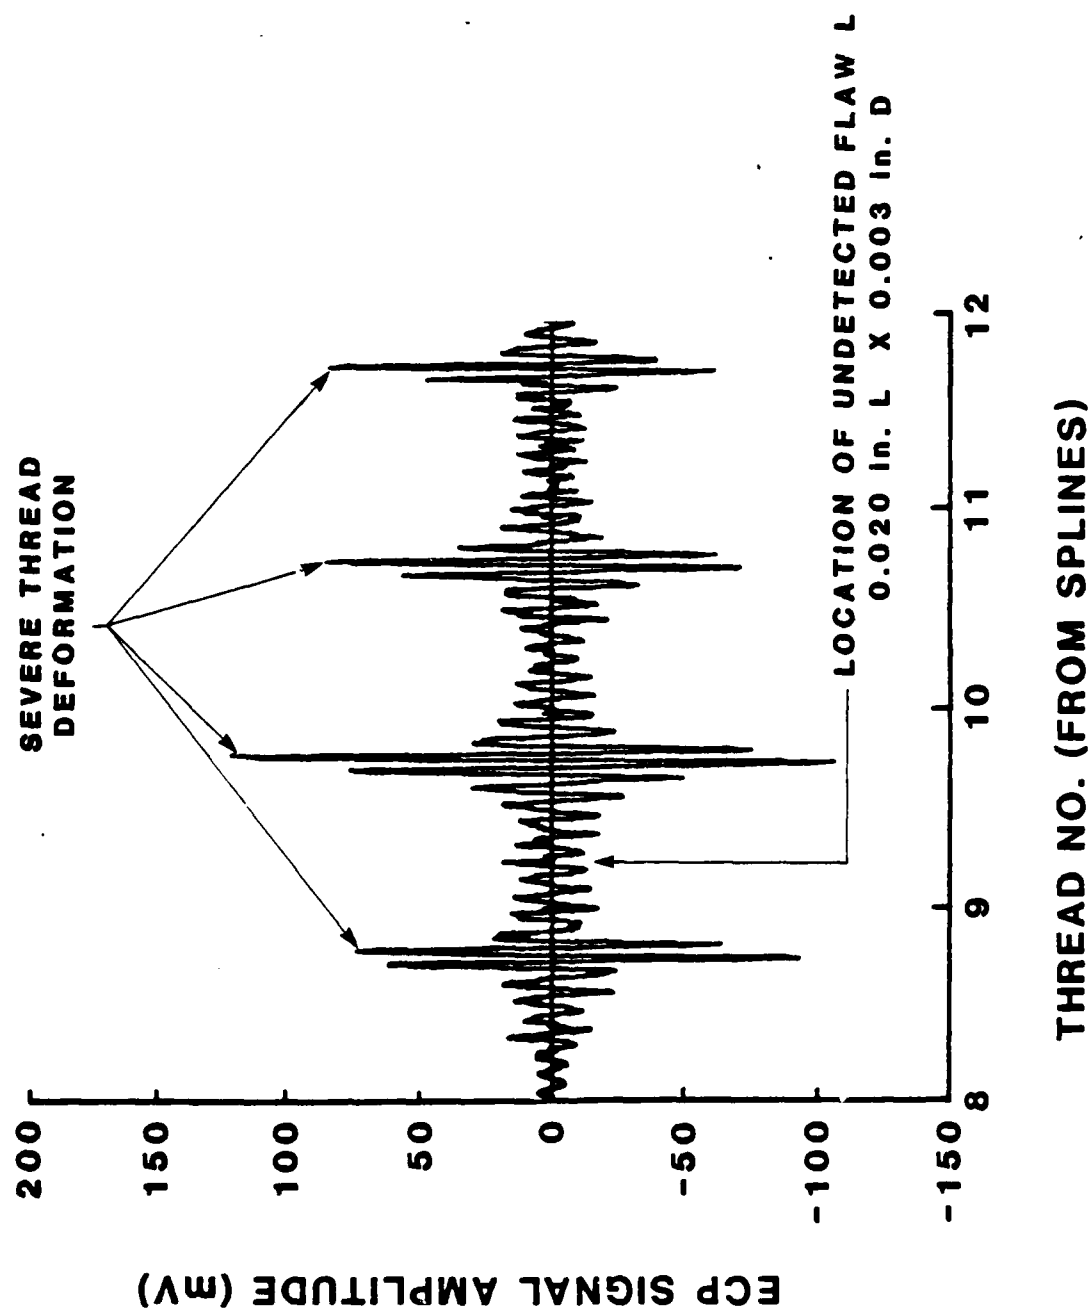
Flaw L (0.020 in. L. x 0.003 in. D.) was not detected (Figure 5). This is not surprising since this flaw is very shallow. Flaw M which is located in thread 15 near the end of the spindle is in a region where the background noise level is high due to mechanical vibration caused by the probe holder extending beyond the end of the spindle (Figure 6). Therefore, a signal from this flaw is not apparent. This problem could be corrected by re-design of the probe bearing block if it is necessary to scan all of the threads. Because of this problem, the last thread was not scanned in all of the spindles.

FIGURE 5. ECP SIGNALS FROM SPECIMEN NO. 2, THREADS 8-12

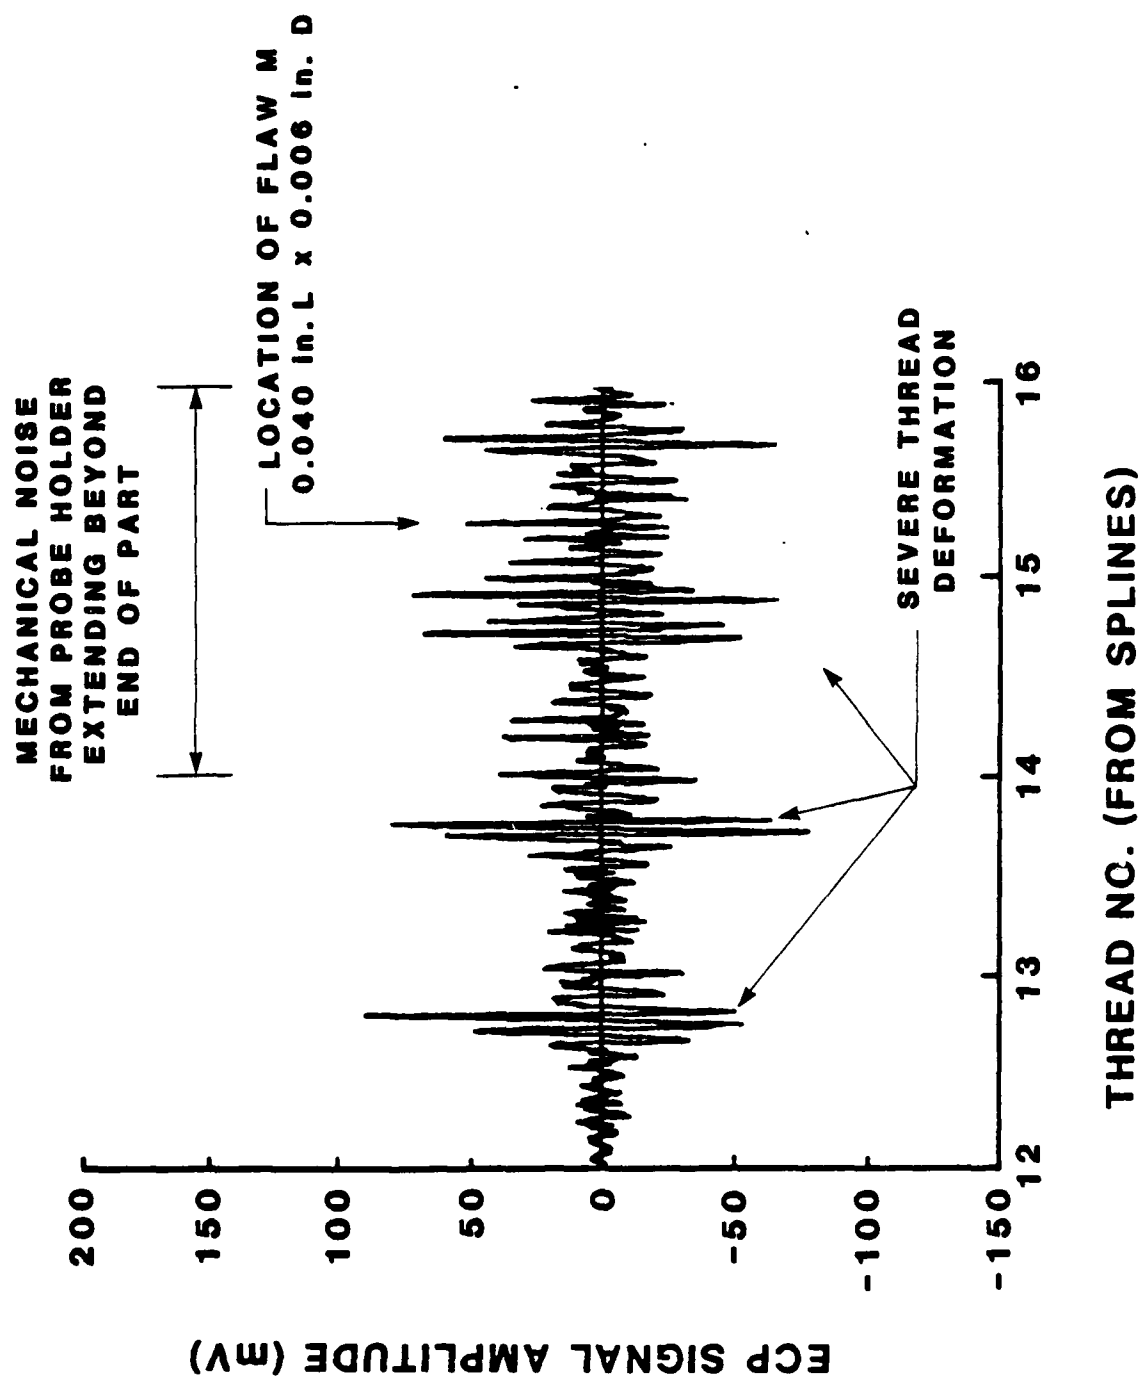
FIGURE 6. ECP SIGNALS FROM SPECIMEN NO. 2, THREADS 12-16

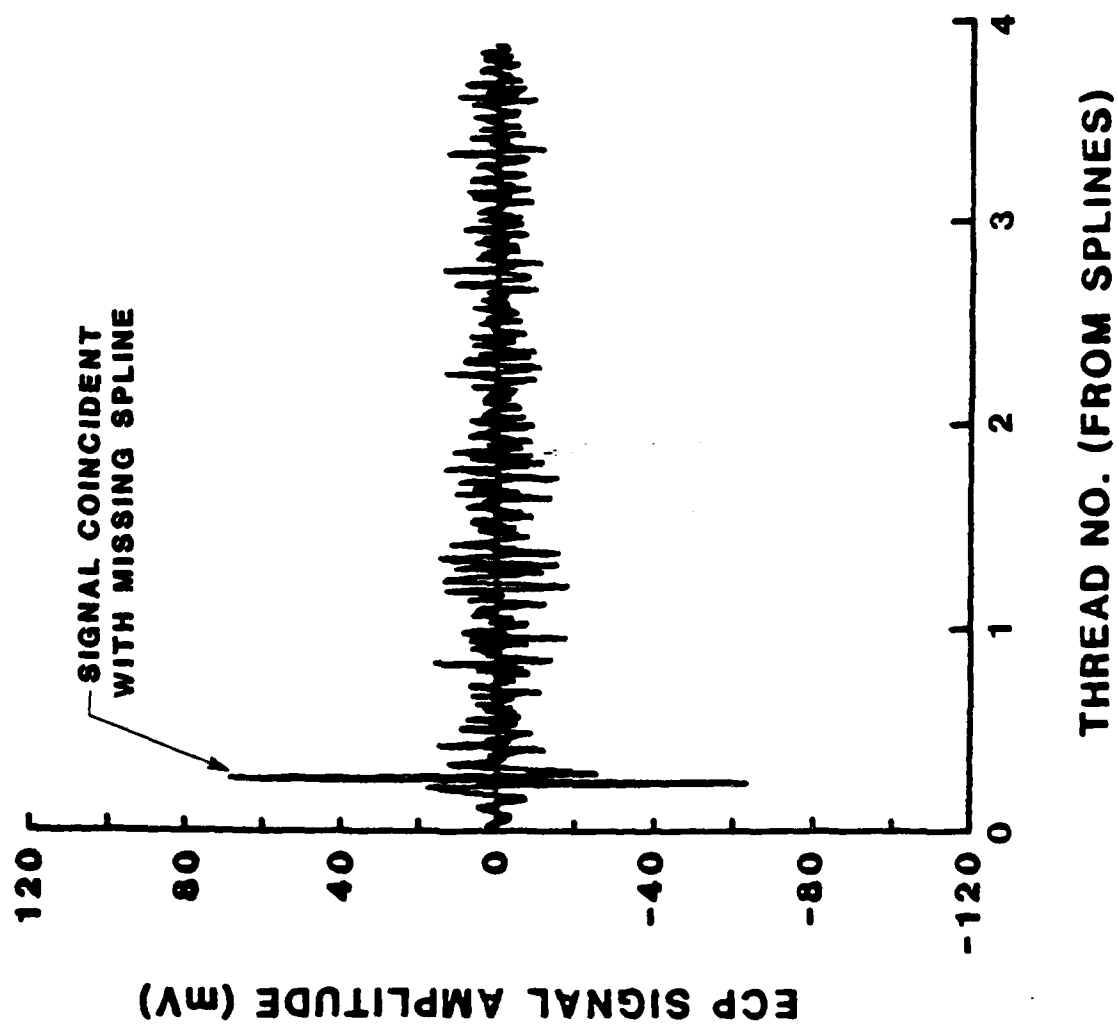
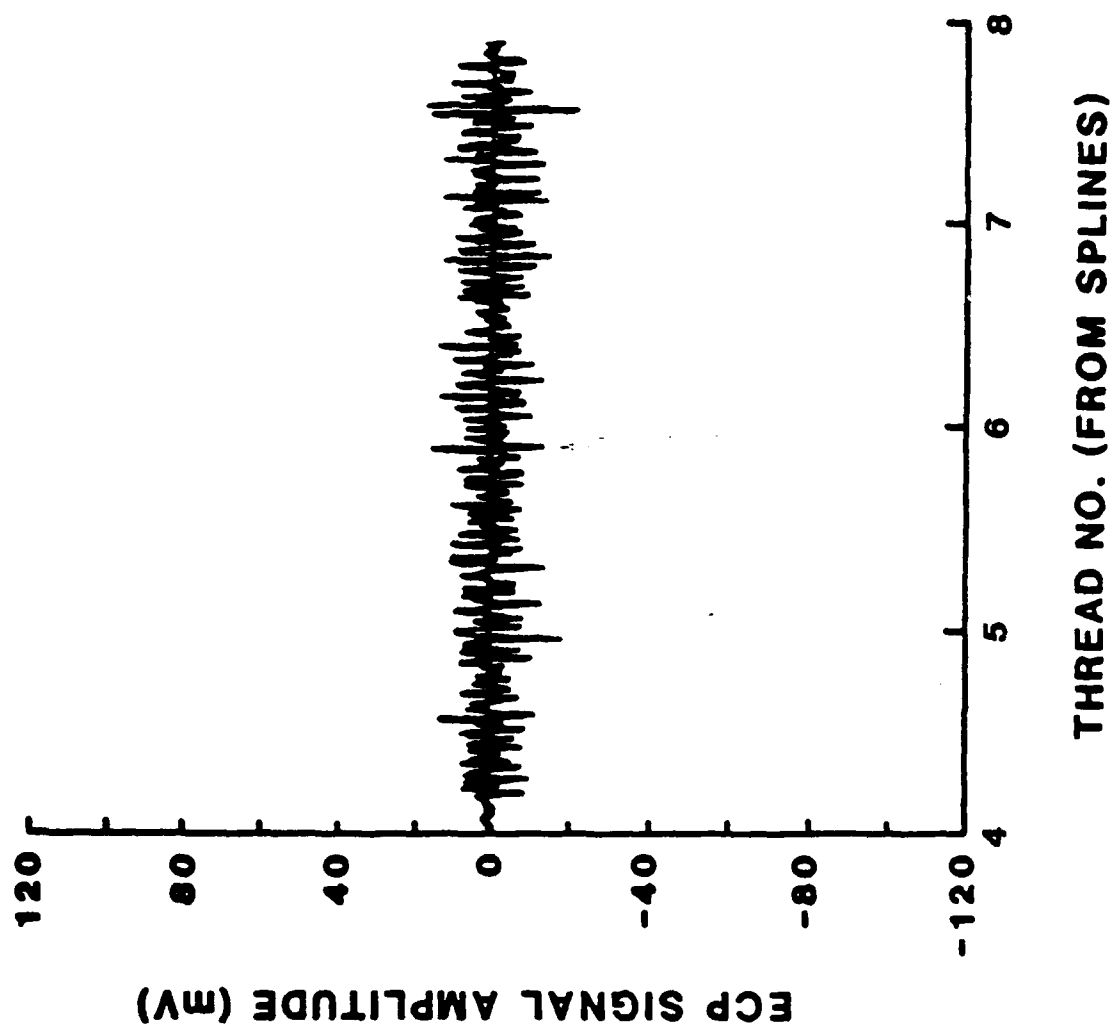
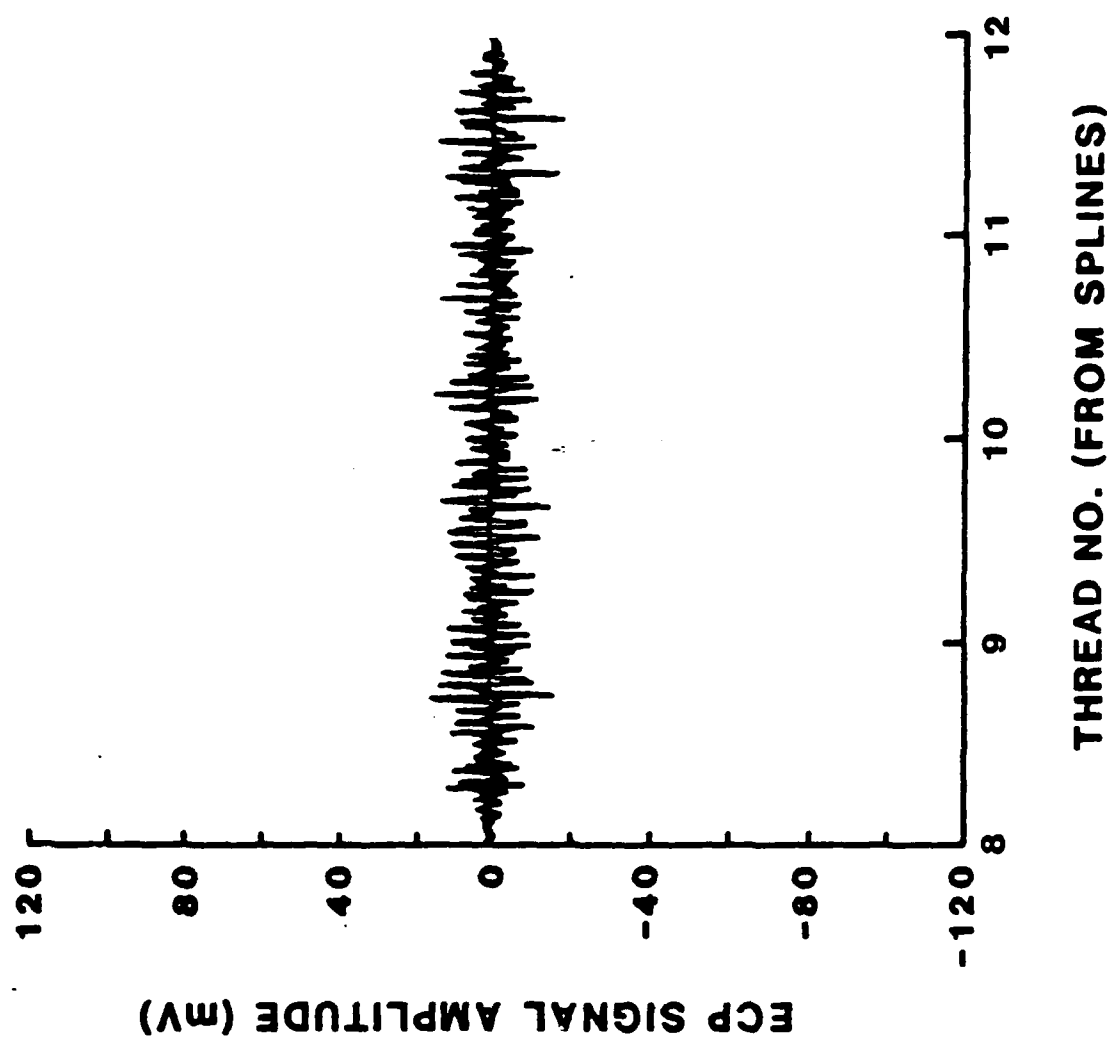
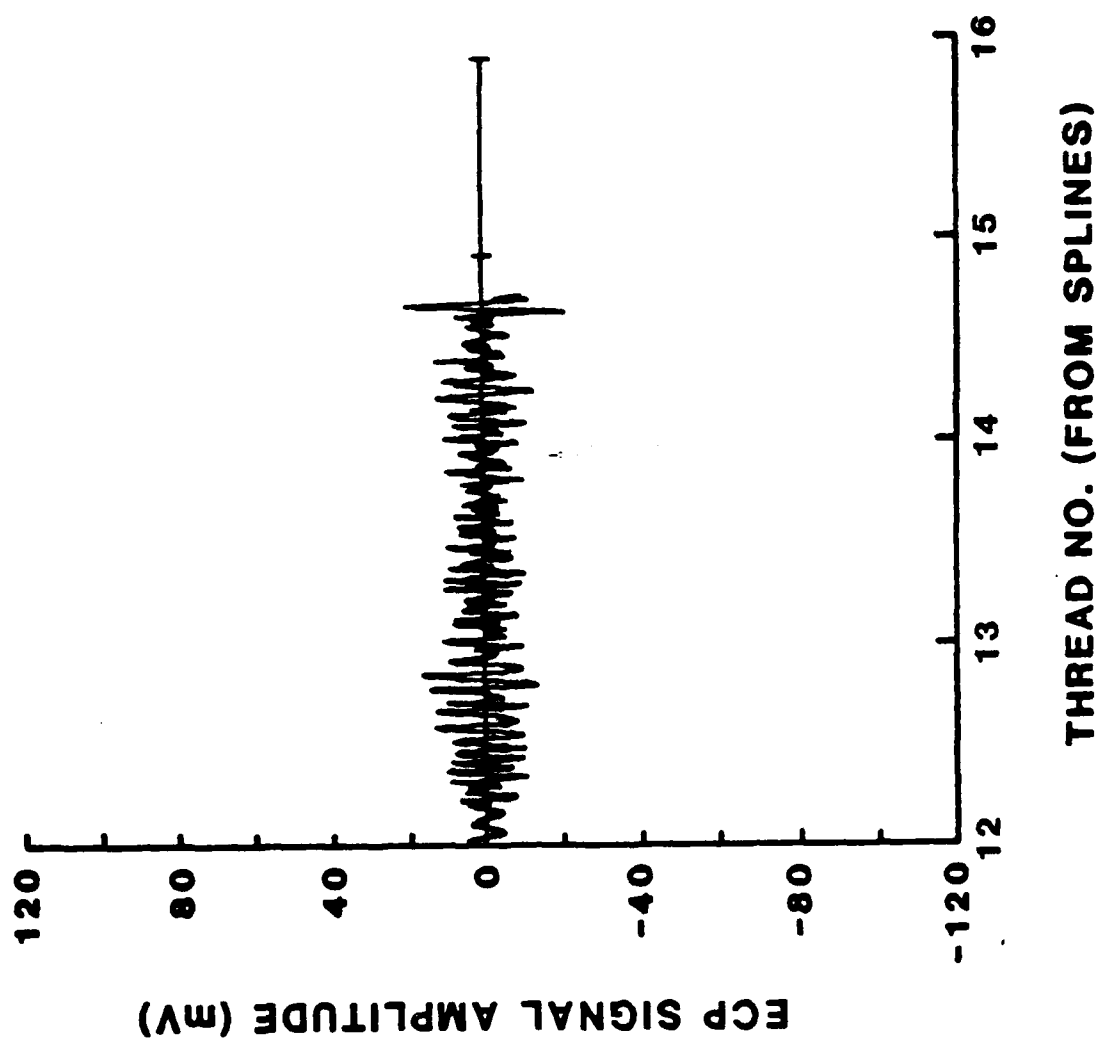
as to the location and other details of the indications; however, the indication was apparently from well below the thread root surface which would indicate that it most likely was not caused by a fatigue crack. No ECP indications were obtained from this spindle except for the signal coincident with the missing spline which was observed on the other spindles as well. The ECP data from spindle No. 3 are shown in Figures 7 through 10. Note that the vertical scale has been expanded compared to Figures 3 through 6. The signal coincident with the missing spline is evident in Figure 7. The background signal level from the remainder of the spindle is relatively uniform and no distinct flaw indications are evident.

Provided an actual subsurface flaw exists as indicated by the ultrasonic inspection, the ECP probe used here would not necessarily be sensitive to it since the probe is designed for detection of surface and slightly subsurface flaws. A metallurgical analysis to determine the source of the ultrasonic flaw indication is apparently planned by Sikorsky Aircraft.

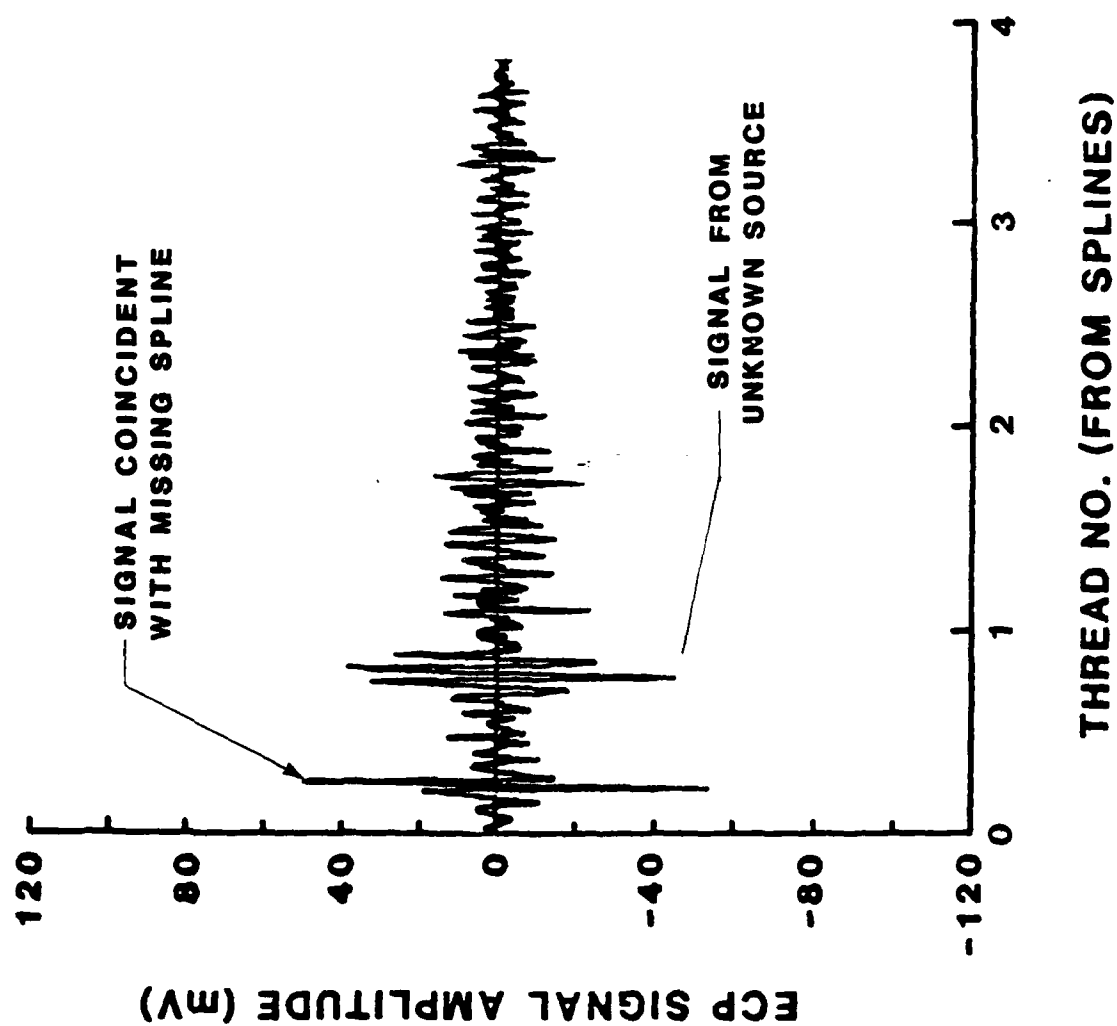
The ECP data from spindle No. 4 which has 12.6 service hours are shown in Figures 11 through 14. This spindle contained a tie rod and no effect of the rod on the ECP signal could be determined. A small indication, slightly above background signal level, was obtained in the first thread as shown in Figure 11. The source of the indication was not identified since this was beyond the scope of the project. A comparison with Figure 2 shows that the signal amplitude from this indication is slightly smaller than the ECP signal from a 0.039 in. L. x 0.010 in. D. artificial flaw. No other flaw indications were obtained from this spindle.

FIGURE 11. ECP SIGNALS FROM SPECIMEN NO. 4, THREADS 0-4

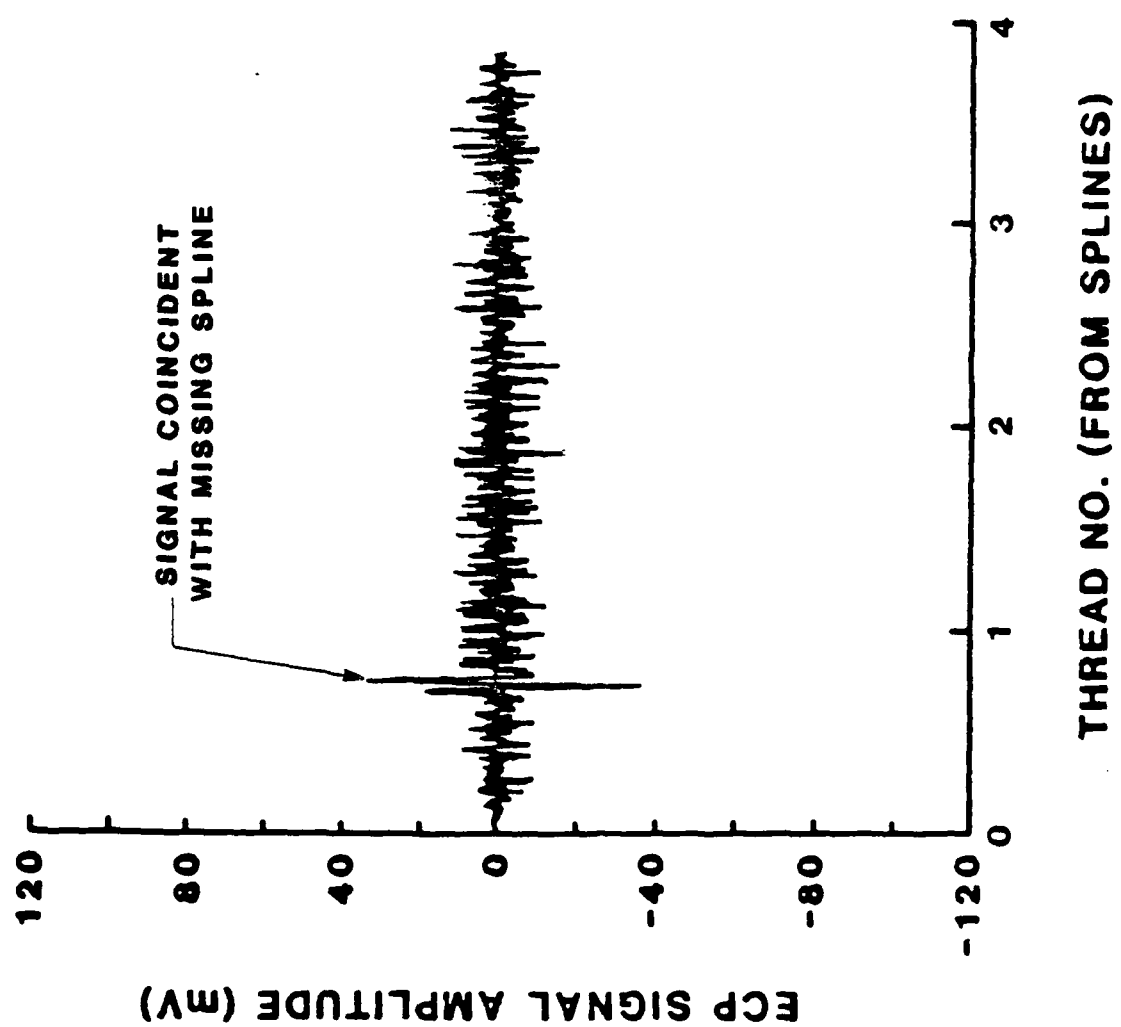
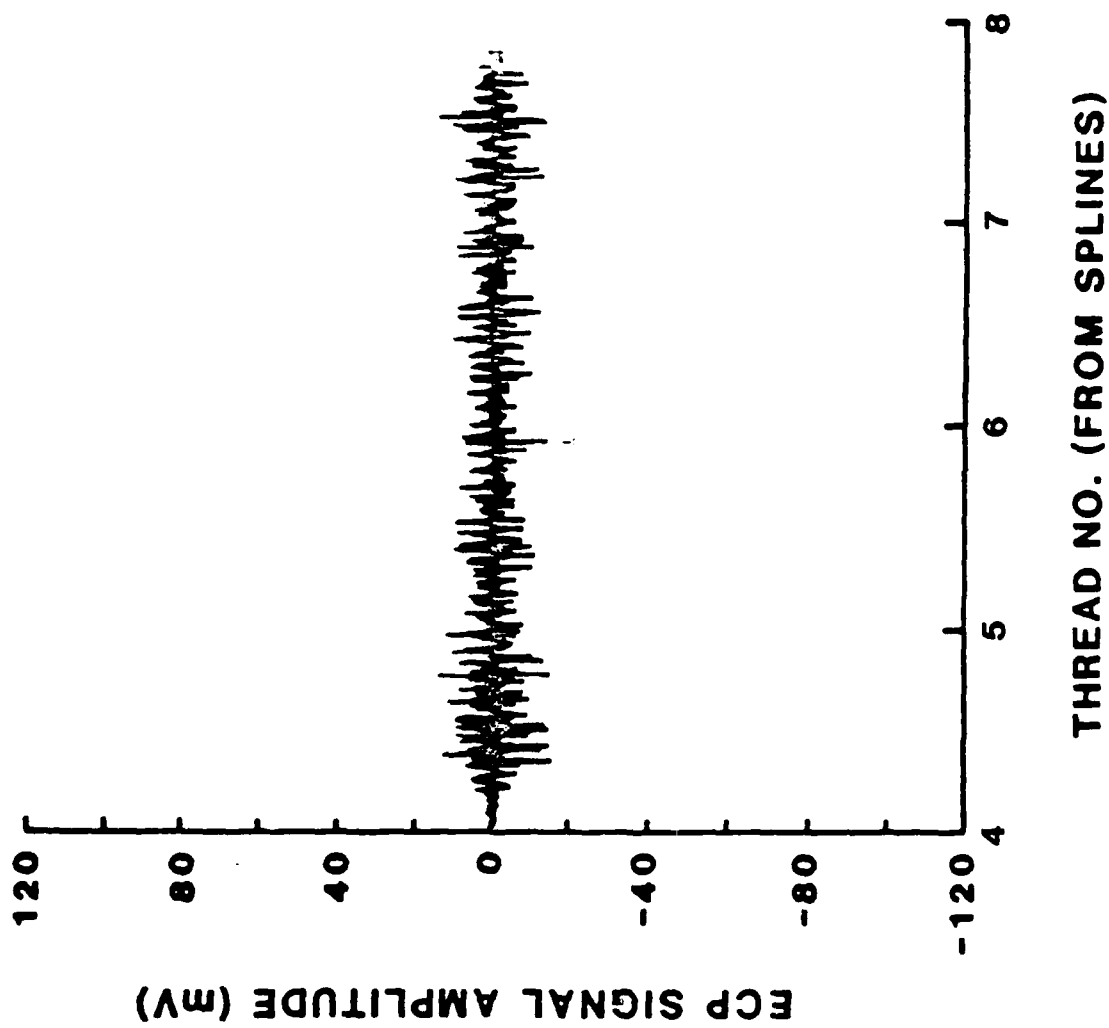
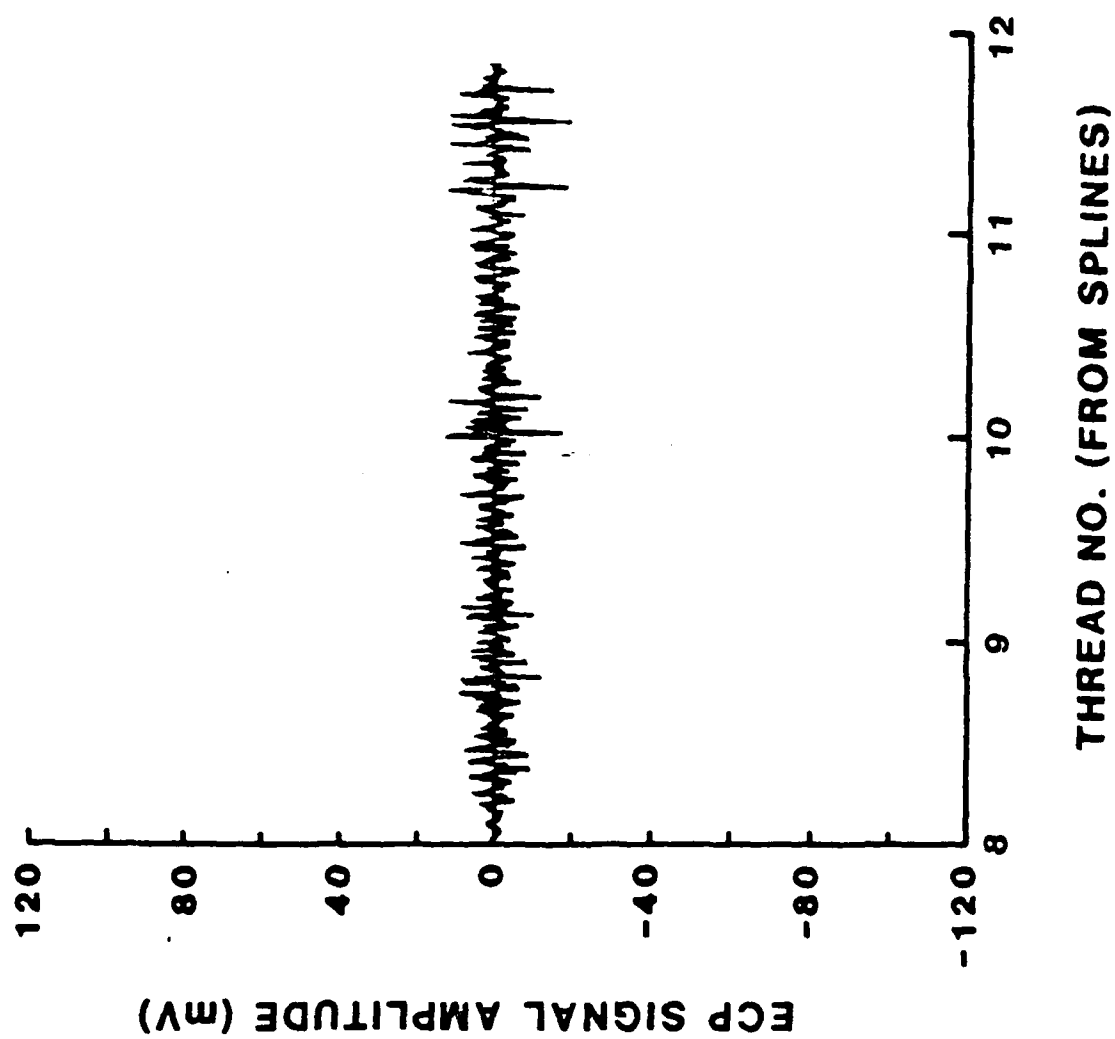
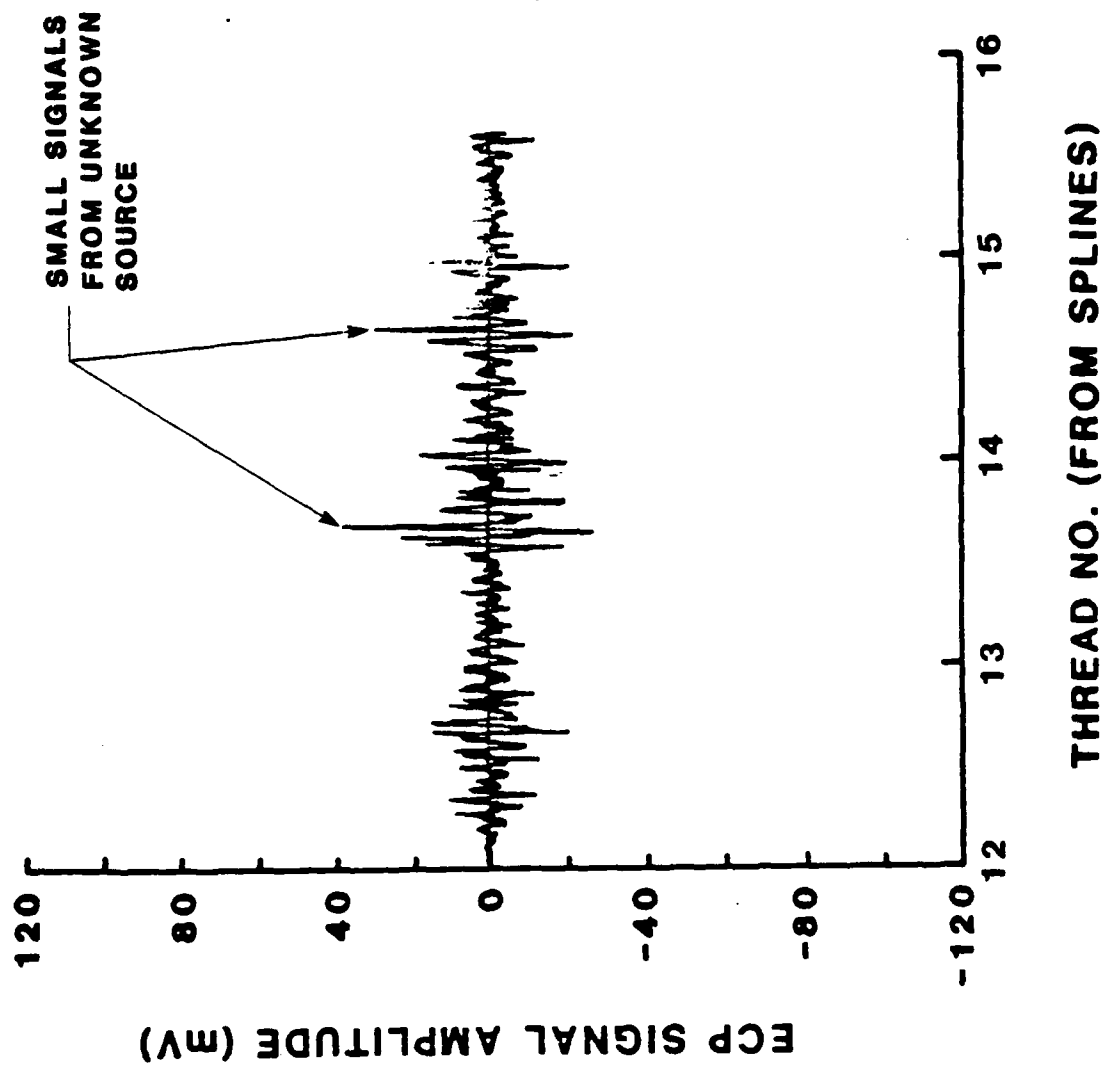
ECP data from specimen No. 5 are shown in Figures 15 through 18. Very small indications, slightly above background signal level, were obtained near the end of the spindle in threads 13 and 14. The angular location of these indications correspond with the location of the "0" stamped on the end of the spindle. The source of these indications was not determined.
